State of Illinois
DEPARTMENT OF TRANSPORTATION
Bureau of Research and Development

EXPERIMENTAL PAVED SHOULDERS ON FROST SUSCEPTIBLE SOILS

IHR-404
FINAL REPORT

March 1972

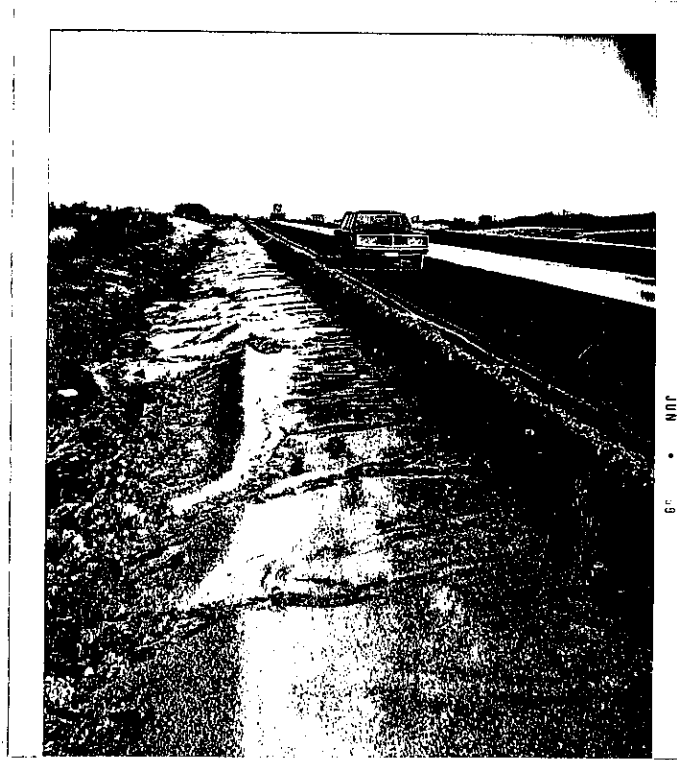
Figure 6. Type A aggregate tended to saturate with rainfall and wash during rains.

The washed sand that was furnished to meet the Type A subbase material specification was difficult to compact. It supported the compaction equipment when moistened, but after drying lost its density when disturbed. It was especially troublesome in the median shoulders where it gave way under the 4-foot rollers and allowed them to tip sideways. As mentioned earlier, the Type A material also washed badly during rains, and required reworking before placement of the next structural layers.

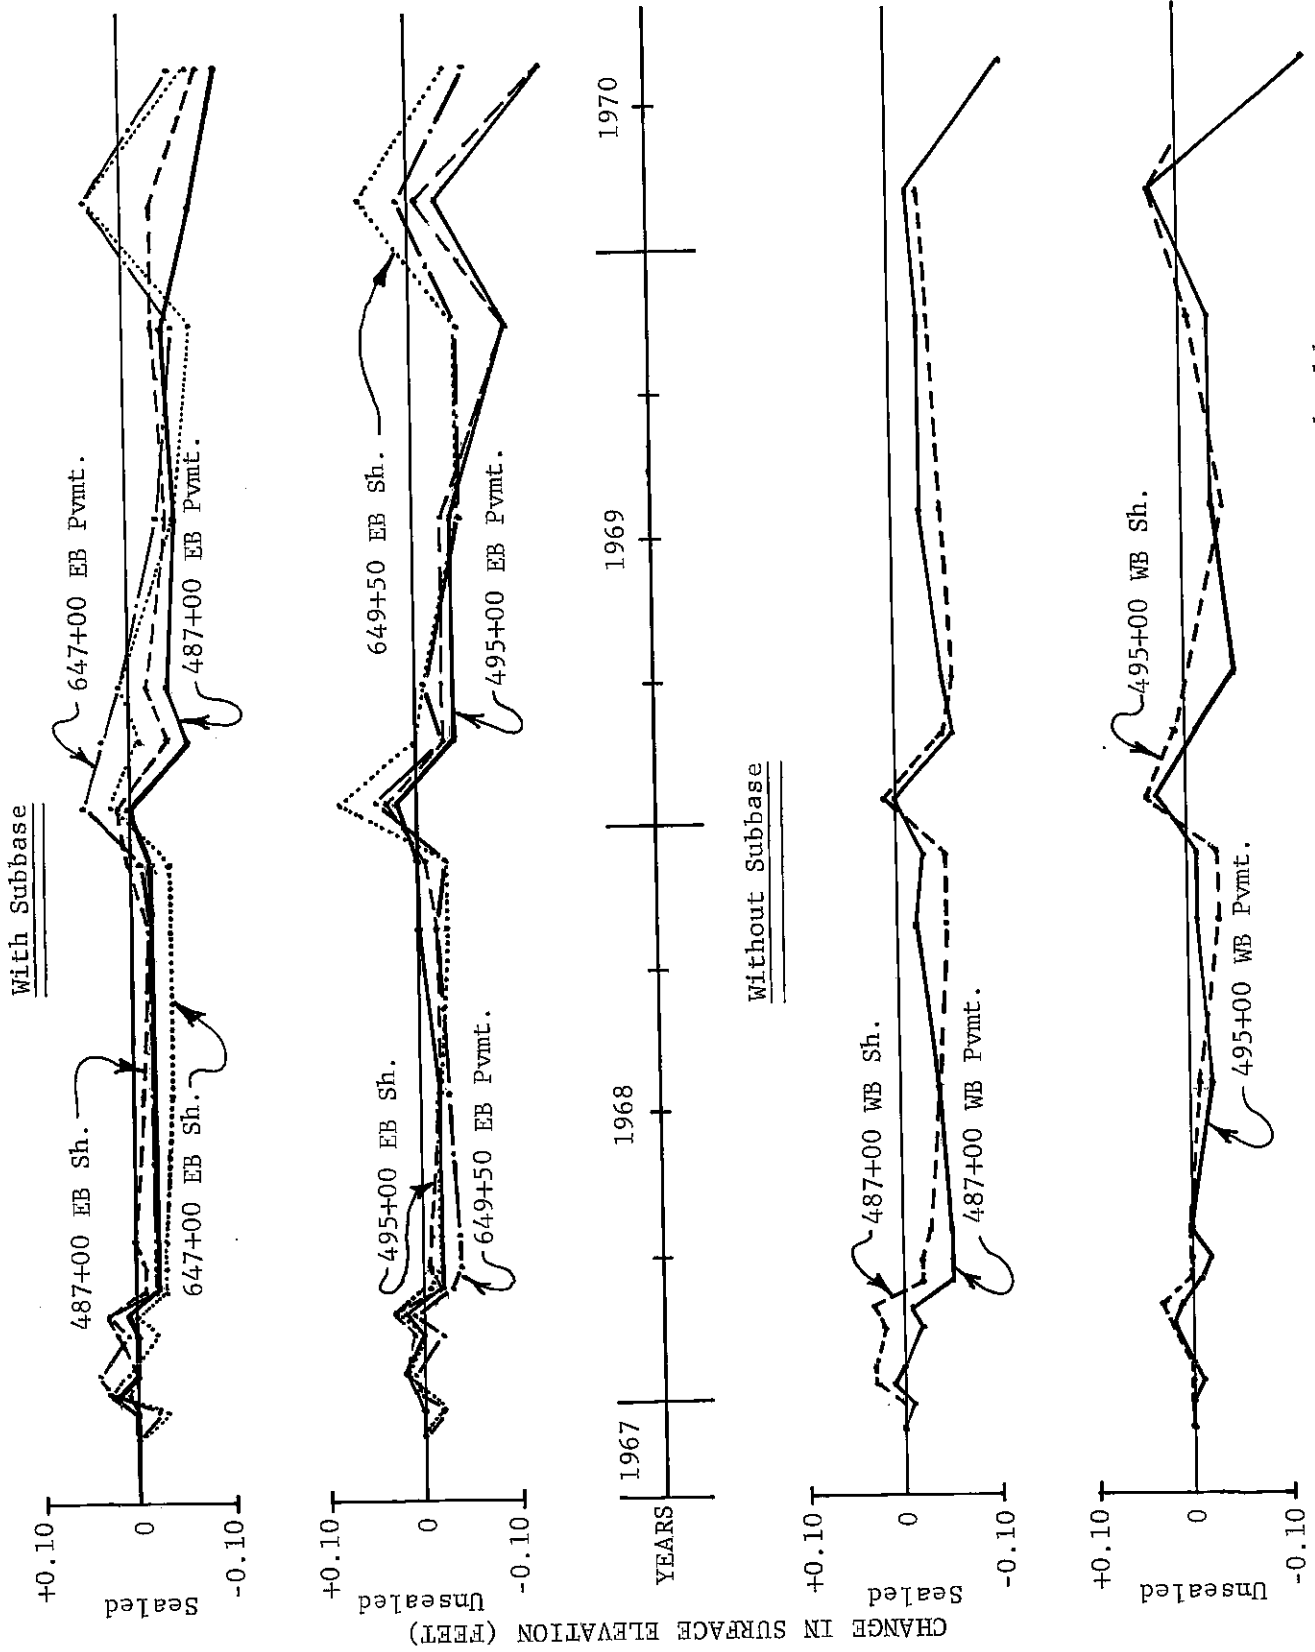
It is evident from the figures that the pavements and shoulders rose during each freezing season and settled when the frost disappeared. The magnitudes of the movements were irregular and unique to the individual sites. The frost rise amounted to as much as 0.14 feet but was more ordinarily in the order of half that amount or less. Frost heaves were smaller during the first winter after construction than during the second and third winters. Maximum frost heaves occurred during the coldest periods of the year. In the frost-free season, the pavements and shoulders settled back to an elevation which was not necessarily the original elevation. Final elevations were above, below, or approximately the same as the original elevation.

Typically, the direction of movement of the pavements and associated shoulders, both upward and downward, has been the same during any given time period. More often than not, the rise of the shoulders has been slightly greater than that of the pavements, but this pattern has not been completely consistent. The differential movements between shoulders and adjoining pavements have been much smaller than the movements of both. No consistent trend that can be attributed to a particular shoulder type, other than the absence of differential movement where the PCC shoulders were tied to the adjacent pavements, is observable. No general shoulder upheavals

Figure 22. Differential surface elevation change in BAM shoulders.

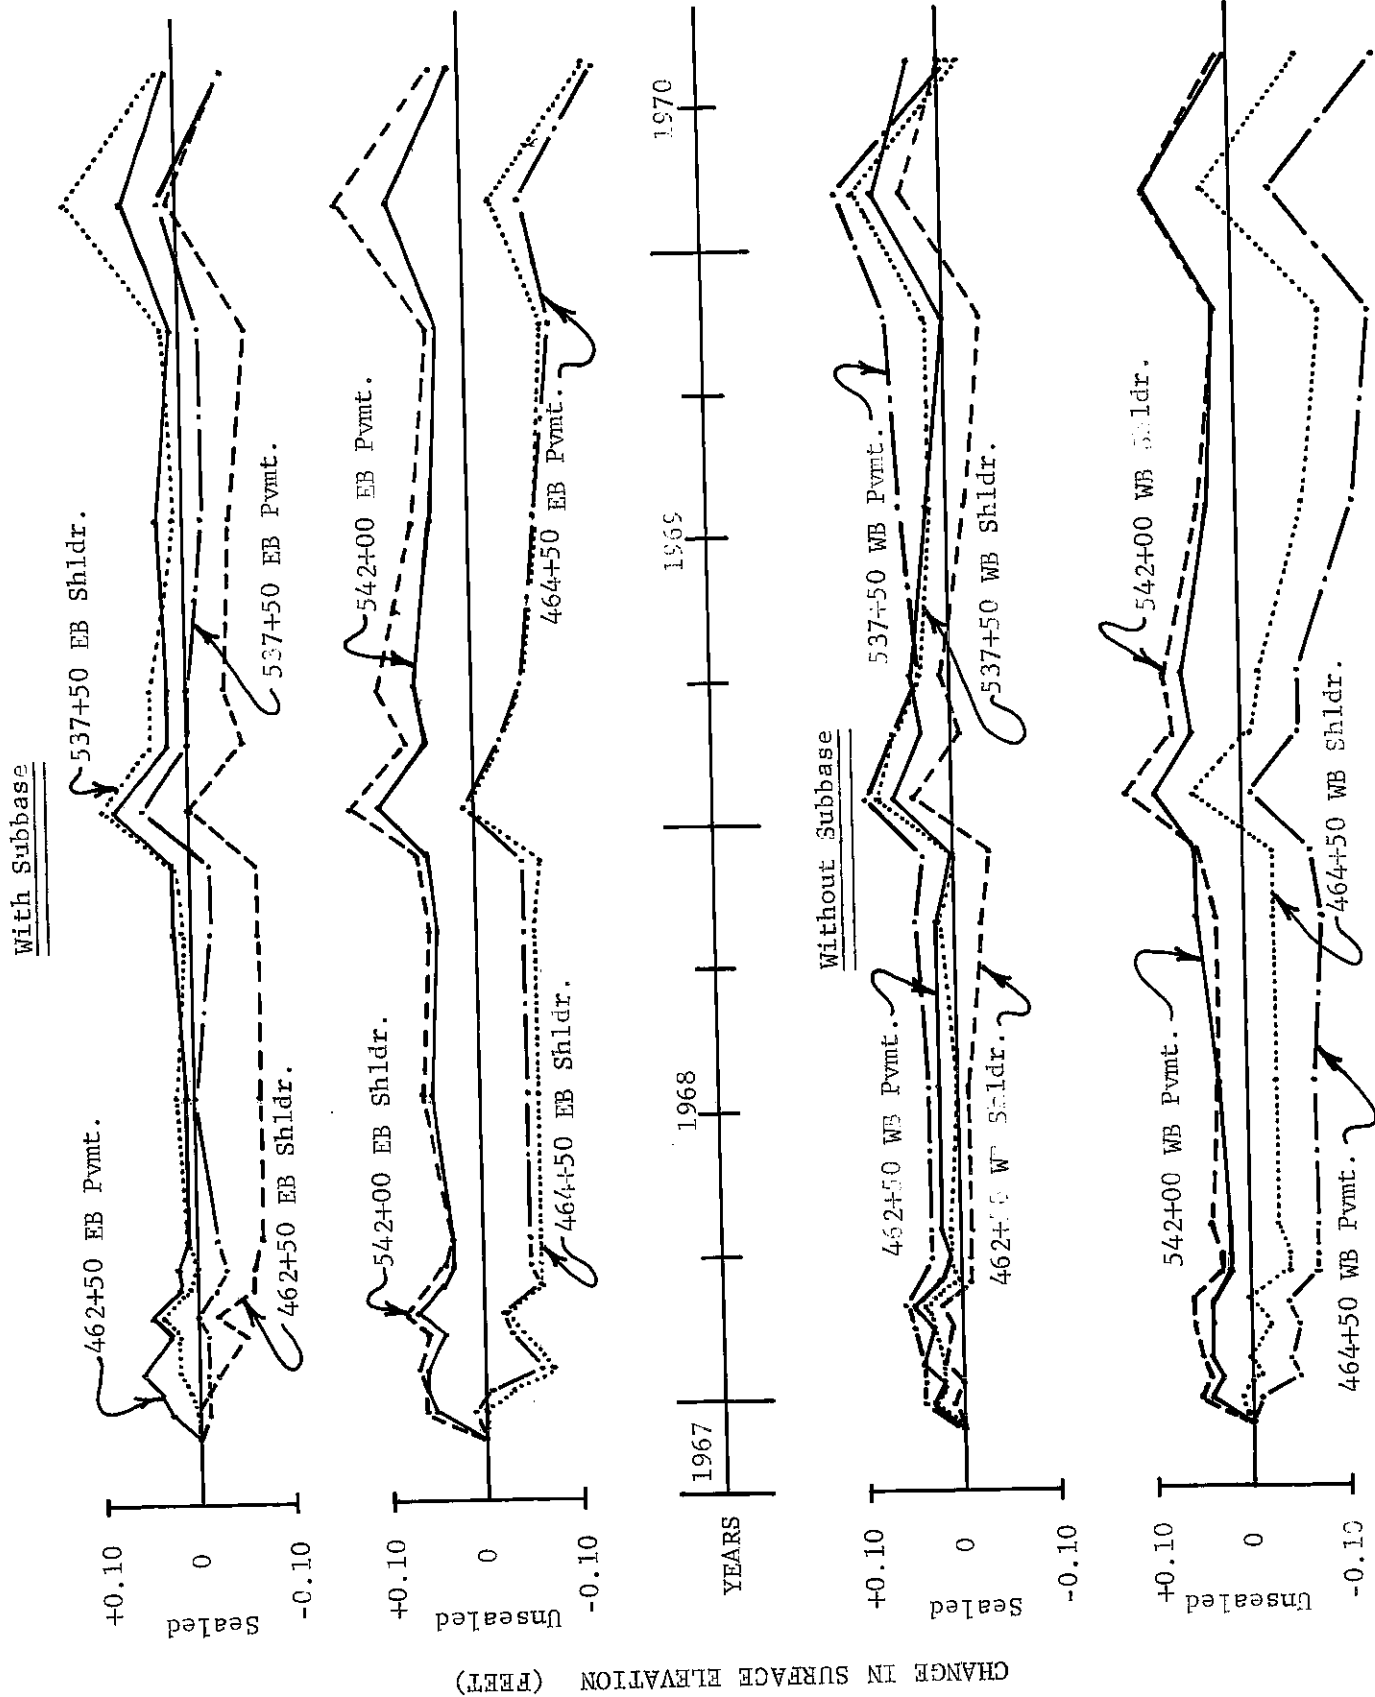
Figure 23. Differential surface elevation change in CAM shoulders.

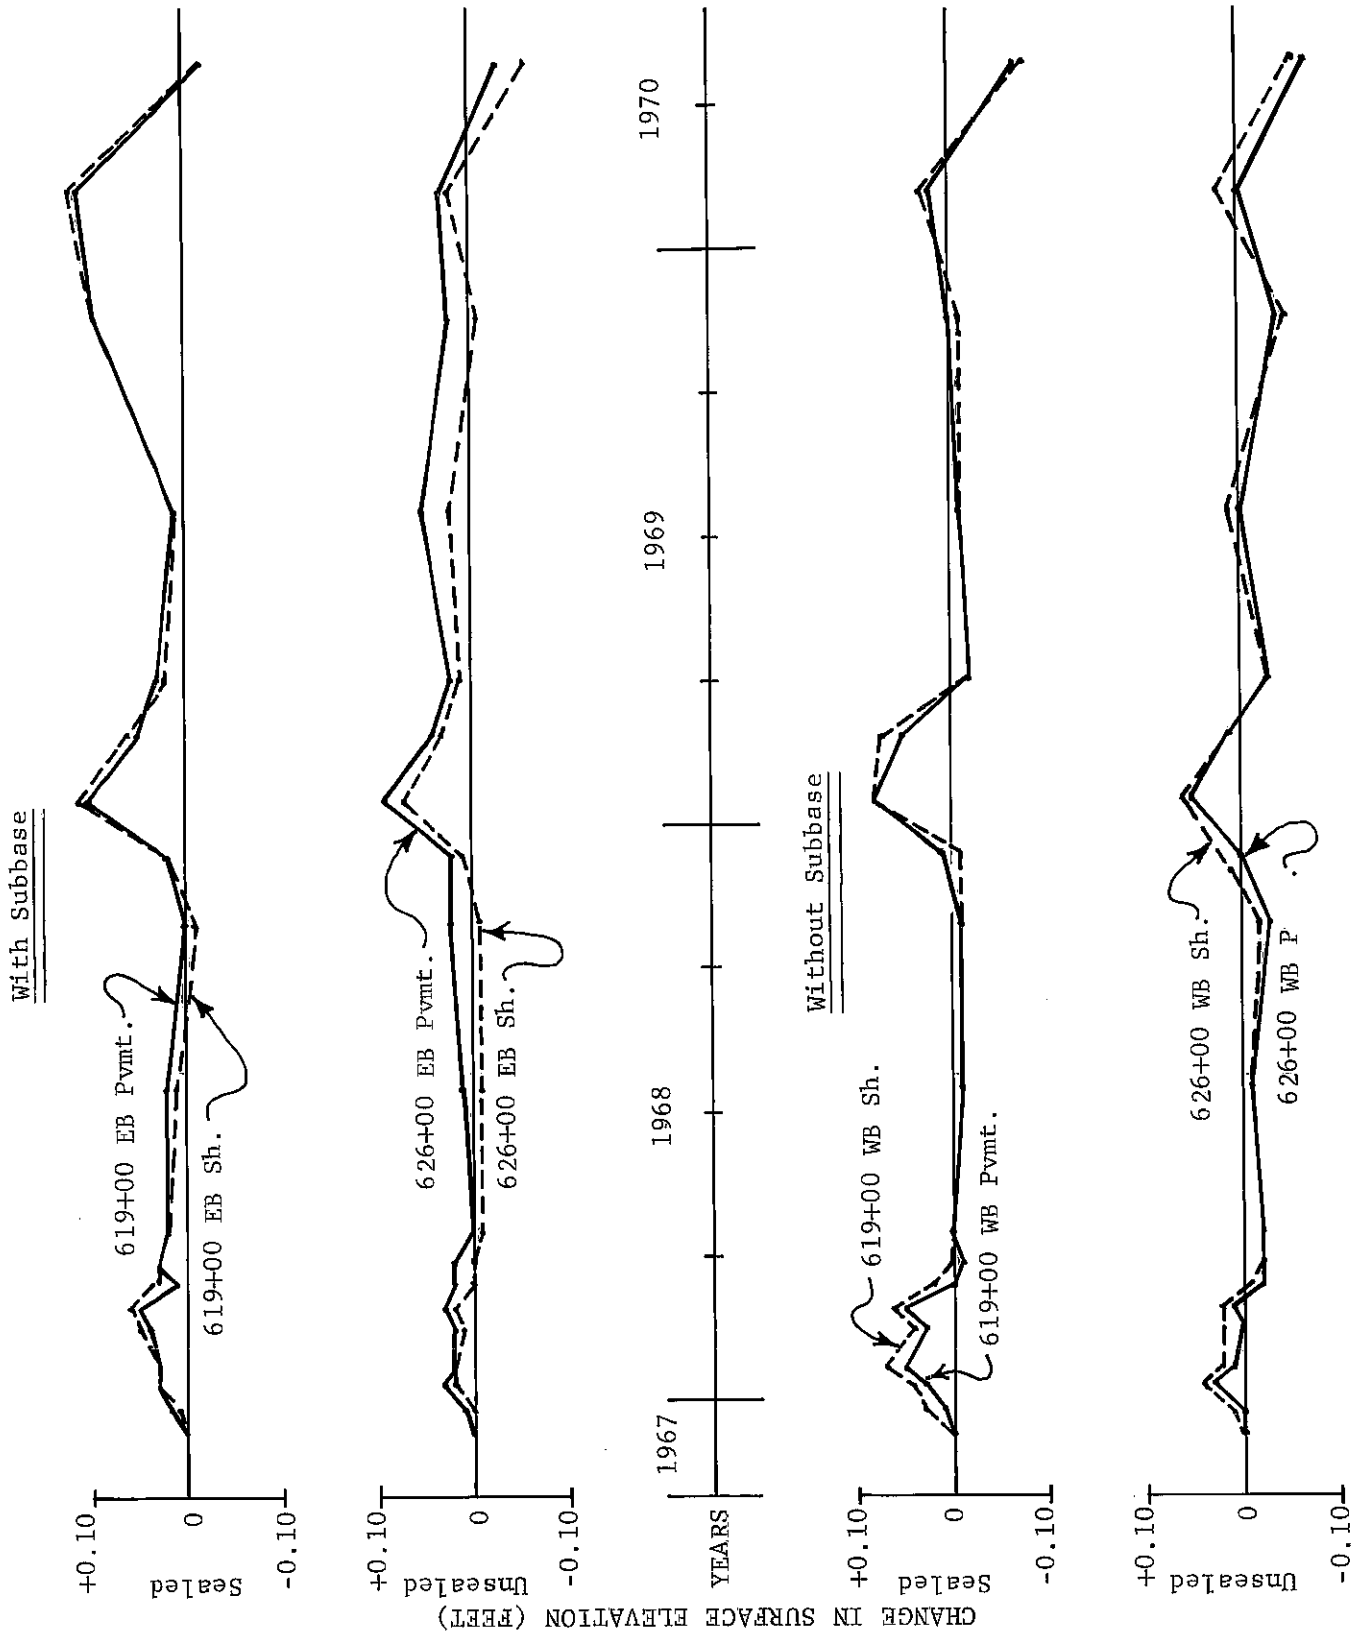
Figure 25. Differential surface elevation change in PCC shoulders.

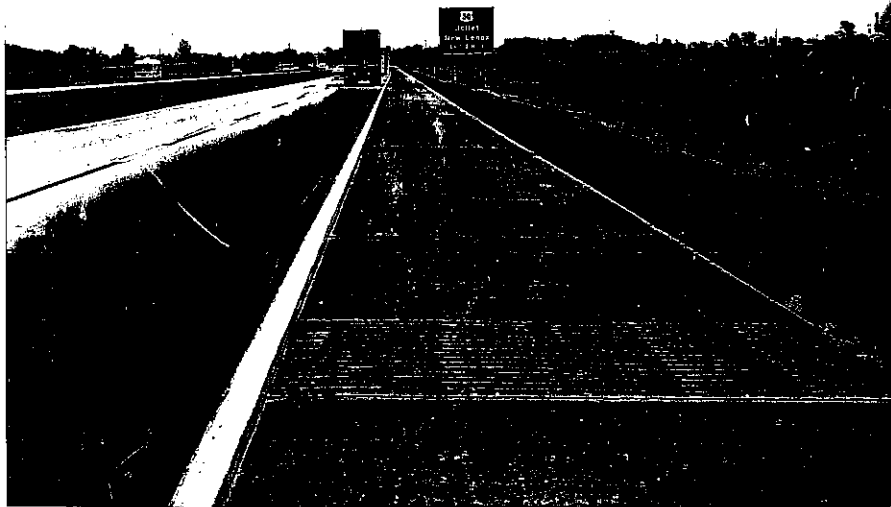
The widespread occurrence of cracking in the shoulders with CAM and PAM bases suggests that CAM and PAM mixtures, at least in the formulations studied, are not appropriate in this usage under the environmental conditions experienced in the experimental area. The BAM shoulders also did not perform well in the experimental section, which is at variance with rather broad experience with this type of shoulder in regular construction elsewhere in Illinois. The predominant type of failure in the BAM shoulders (alligator cracking, accompanied by depression) suggests an inadequacy of the structure in supporting the applied loads. The PCC shoulders, although showing a small amount of intermediate cracking in the constructed 20-foot

Figure 29. Outer portland cement concrete shoulder adjacent to eastbound pavement.
